Wanessa-Sue, Inc.
5456 Inez Road
Kingman, AZ 86409

Report No: STQA50779.1R0
Date: July 31, 2020
Page No: 1 of 13

Axial & Transverse Load Tests of
10-ft Airlight Panels
Pursuant to ASTM E72

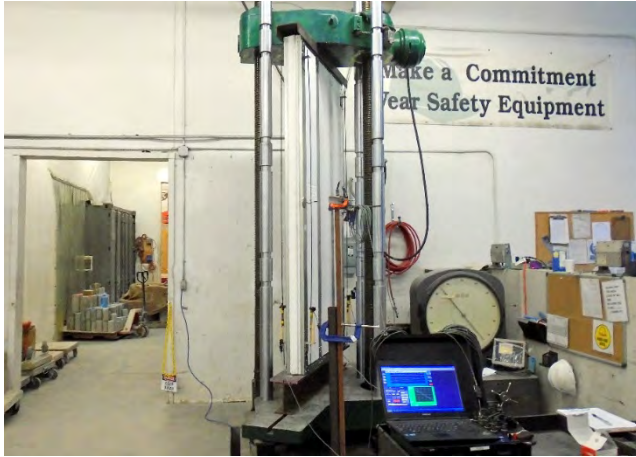
Photo 1: Axial Compression Load Test Set Up

The axial load test was set up as follows: The test apparatus was set-up in general conformance with Section 9 and Figure 2 of ASTM E72. The test specimens were positioned onto the UTM for the compressive load tests as follows:

- A 3/8-in. thick x 5-in. wide x 5-ft. long "I" beam was placed on the bottom of the platen of the UTM. A 3/8-in. thick x 5-3/4-in. wide x 5-ft. long steel plate was placed on the top flange of the "I" beam. The test specimen was positioned on the steel plate. A 3/8-in. thick x 7-in. wide x 5-ft. long steel "C" channel was placed on top of the test specimen. The test specimen was positioned in the test fixture to support a uniform axial load applied with an eccentricity of one third the panel thickness.

- Four compressometers (LVDTs) were set-up per Figure 2 of ASTM E72 to measure compression of the test specimen. Two deflectometers (LVDTs) were set-up on an independent datum post adjacent to the UTM (this set-up deviated from the ASTM E72 set-up) to measure the out of plane deflection (referred to as lateral deflection in ASTM E72) of the test specimen. The deflectometers were positioned onto the test panel at mid-height

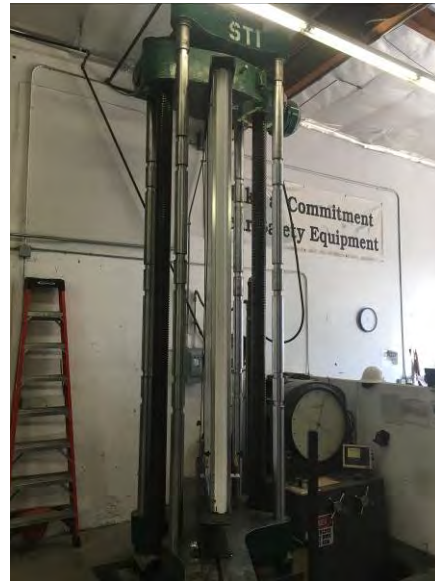
Photo 2: Axial Compression Set Up

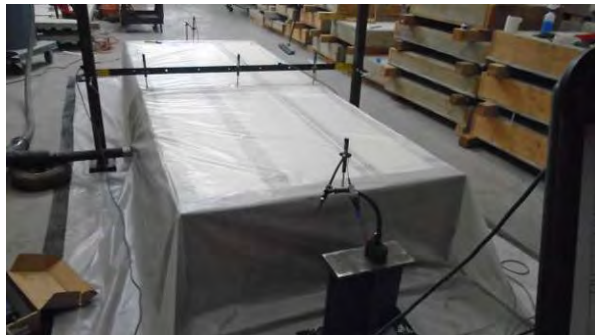
Photo 3: Transverse Load Set Up

The transverse load test was set up as follows: The transverse load test apparatus was set-up in general conformance with the requirements delineated in Section 11 of ASTM E72. The vacuum bag method as described in Section 11.3.1.3 and Figure 4 of ASTM E72 was used, except that the panel was supported by fastening to the ends. Photographs of the test set up are shown below. Due to problems encountered with achieving an ultimate load using the vacuum method, the test apparatus was switched over to the bladder method and the panels were reloaded to failure.

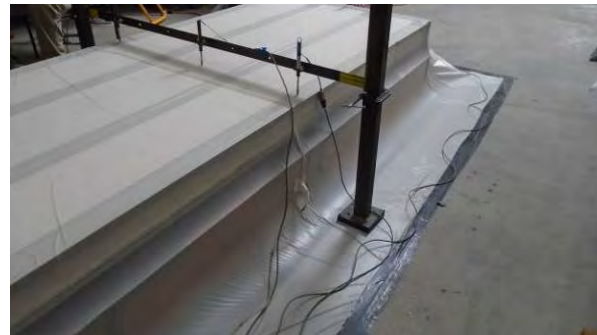
Photo 4: Transverse Load Set Up

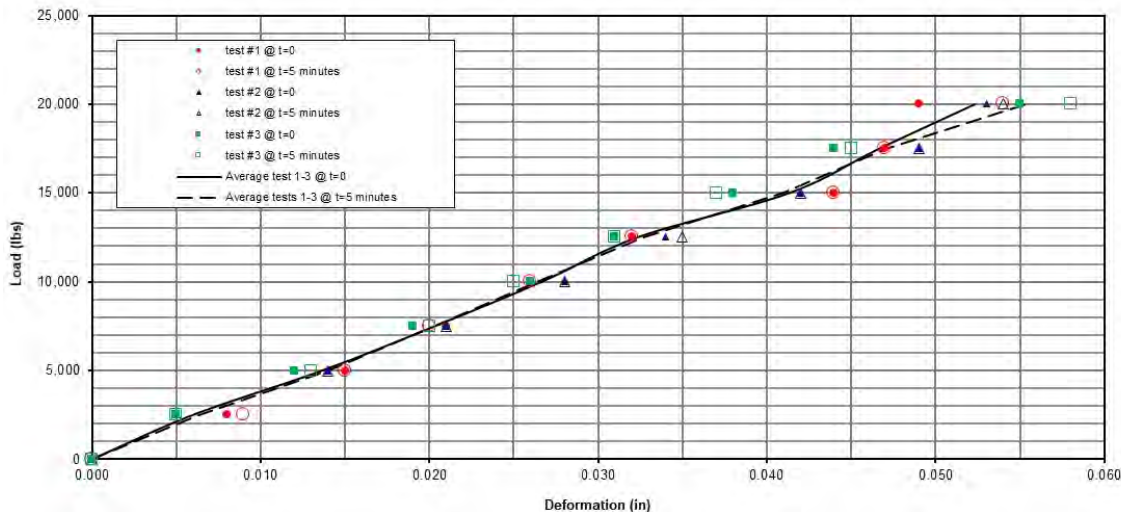
Figure 1: Axial Compression Test, Vertical Deformation

Tables 2 and 3 provides a summary of the axial compression results, and the load-displacements are depicted graphically in Figures 1 and 2.

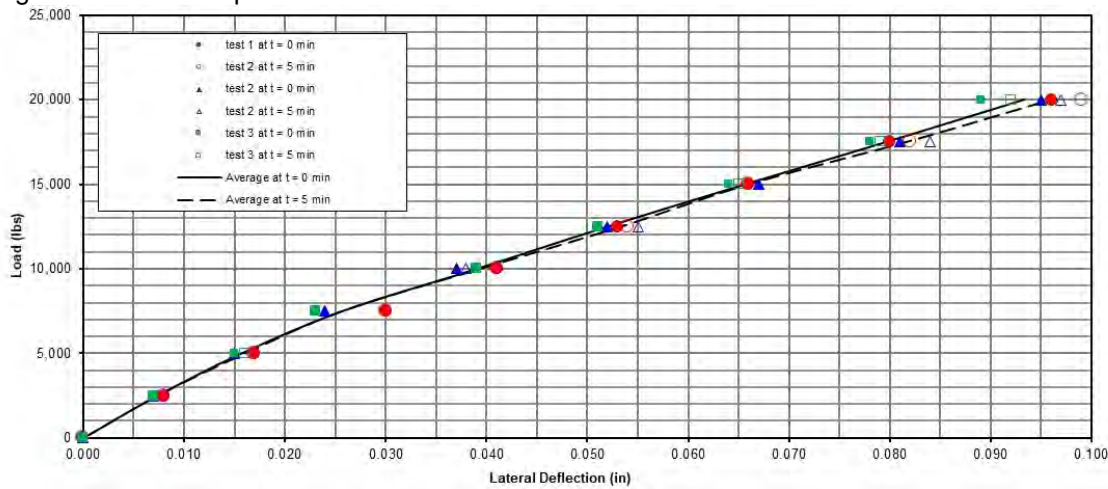
Figure 2: Axial Compression

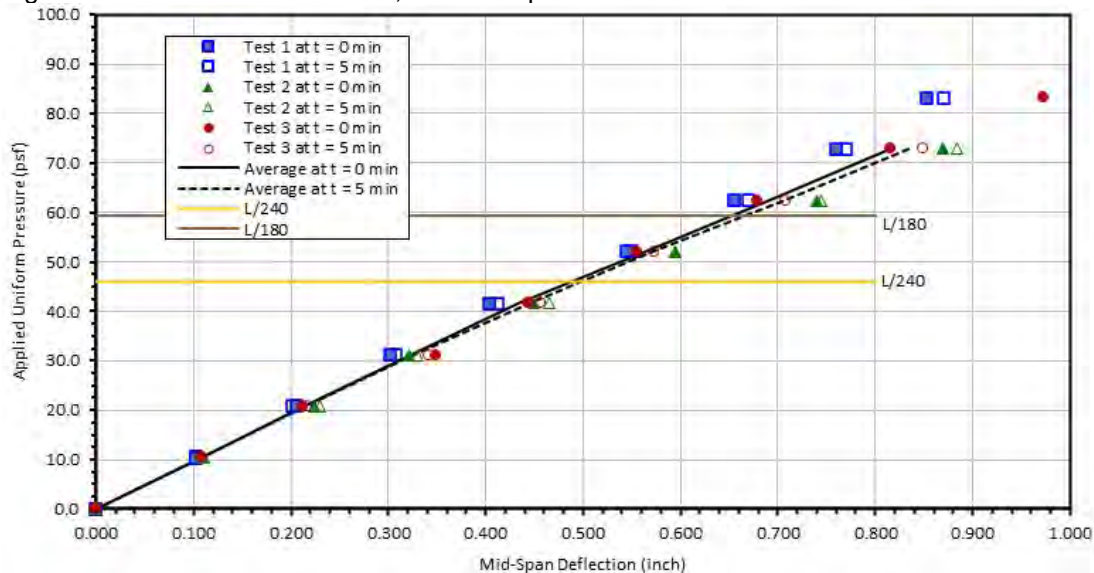
Figure 3: Transverse Load Tests, Net Mid-Span Deformation

Table 4 provides a summary of the transverse load results, and the load-displacements are depicted graphically in Figure 3. Based on the data, and specifically on the average displacement after five-minute holds, the average pressure at a displacement of L/240 is 46.1 psf, and 59.3 psf at a displacement of L/180. The average ultimate load of three test panels was 313.7 psf.

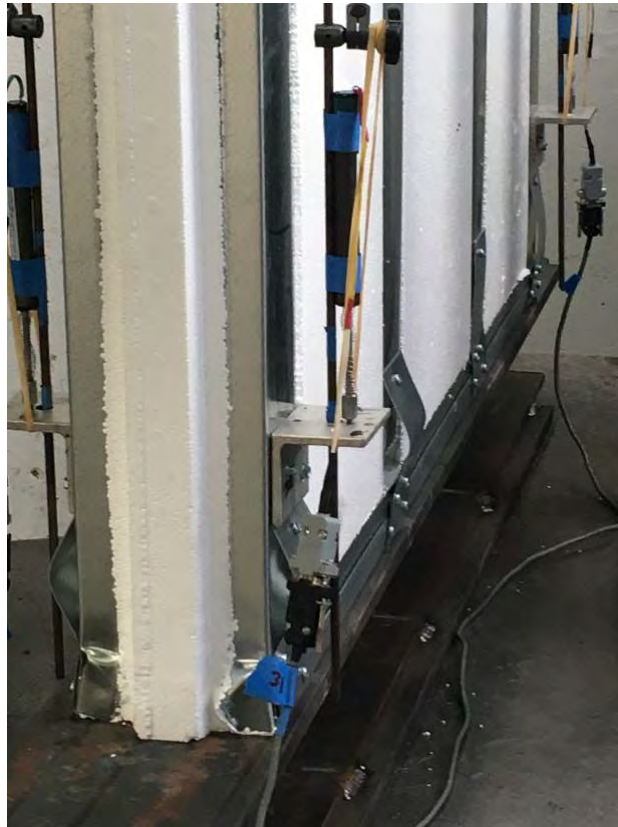
Photo 5: Typical Failure, Axial Load Test

1. The ratio of specimen length (120 inches) to gauge length (106 inches) is 1.132
2. Failure was buckling of the studs and trim at both top and bottom connection to the track

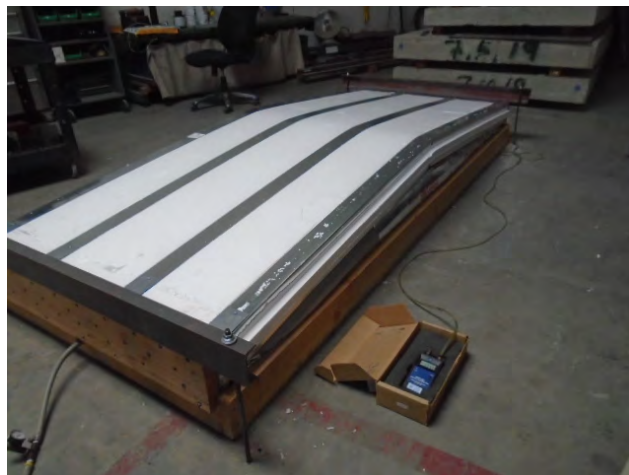
Photo 6: Typical Failure, Transverse Load Test

1. The panels for Tests 1 and 2 eventually would not sustain additional loading; and the panel for test 3 buckled
